Oregon OSHA - ENFORCEMENT

Inspection Number: 317727743(15)
Inspection Date(s): 08/04/2020-12/08/2020
Issuance Date: 12/31/2020
Optional Rpt Num: B1514-047-20
Employer ID No: 8544595-000

Accident Synopsis

Employer Name: River Roofing Bend LLC

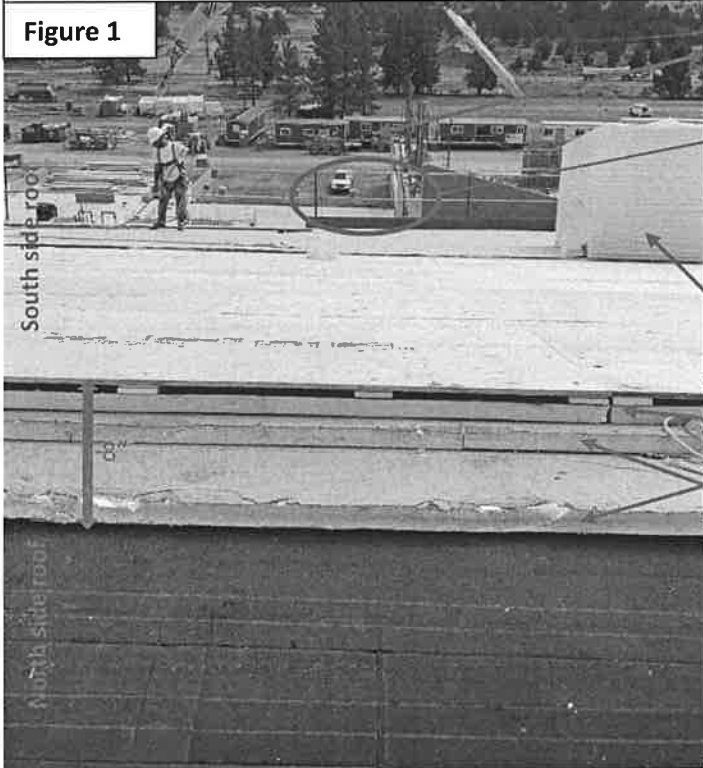
Figure 1 photo (OTIS Image 5851) is taken looking south from near the ridge of the roof. One can observe the combined total transition height of approximately eight inches and the location where the trailer, material and an employee traveled off the roof.

Approximate location of group meeting the day of the incident

Approximate location the trailer rolled off the roof

Figure 1 depicts the south side roof the day after the incident. The guardrail system was in the process of being repaired. Iden Asato reported that nothing else had changed at the scene of the incident

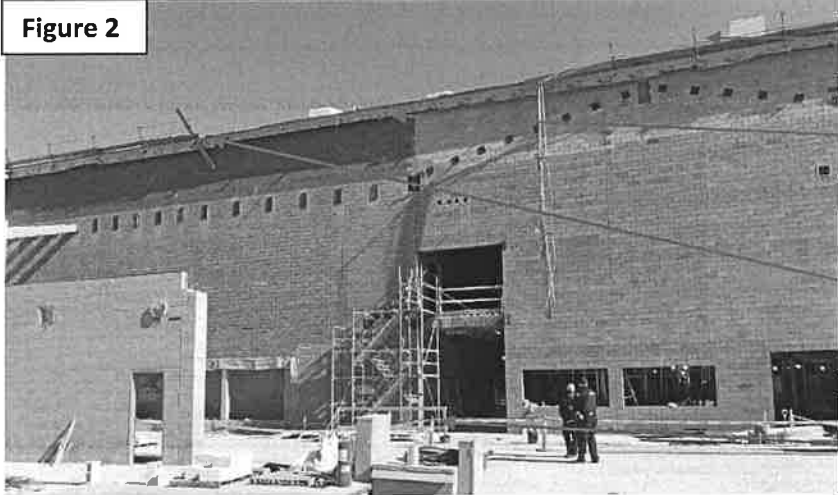
Figure 2

Figure2 (OTIS Image 5821) depicts the scene at the time of the incident. A 50 foot section of guardrail can be seen hanging from the eave of the south facing roof. The Little Giant trailer can be observed on the scaffolding stair tower. Two Bend Police Officers are observed standing at the bottom right of the photo.

Engineered guardrail system

Approximate location of the fall

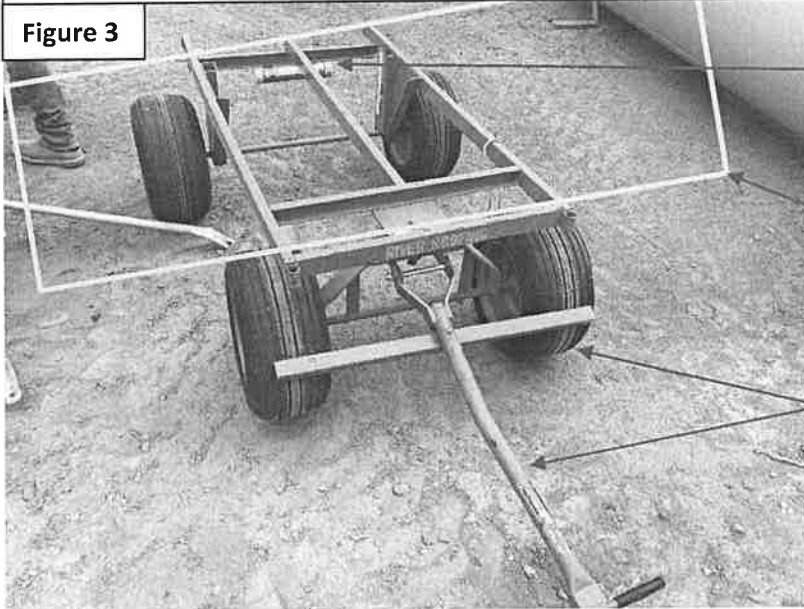
Figure 3 (OTIS Image 5877) depicts the River Roofing owned, 200 pound Garlock Little Giant Trailer that rolled off the south side roof while transporting a bundle of Atlas Cross Vent nail base insulation weighting 907 pounds. The employer reported that little to no damage was detected to the trailer.

Storage container possessing the operator's manual

The position the 4' x 8' sheet material was positioned on the trailer, such as the Atlas Cross Vent nail base insulation, the 2" ridged insulation and HD board

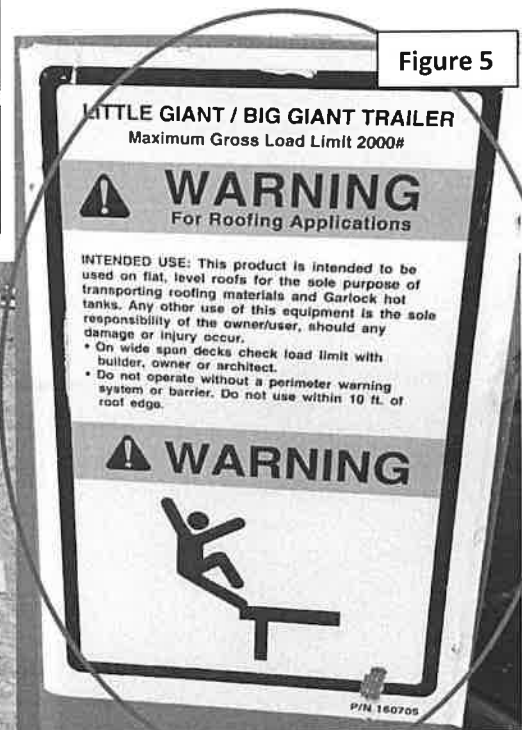
Figure 5 (OTIS Image 5897) depicts the location of a legible label on the Garlock Little Giant trailer that reports that this product is intended to be used on flat, level

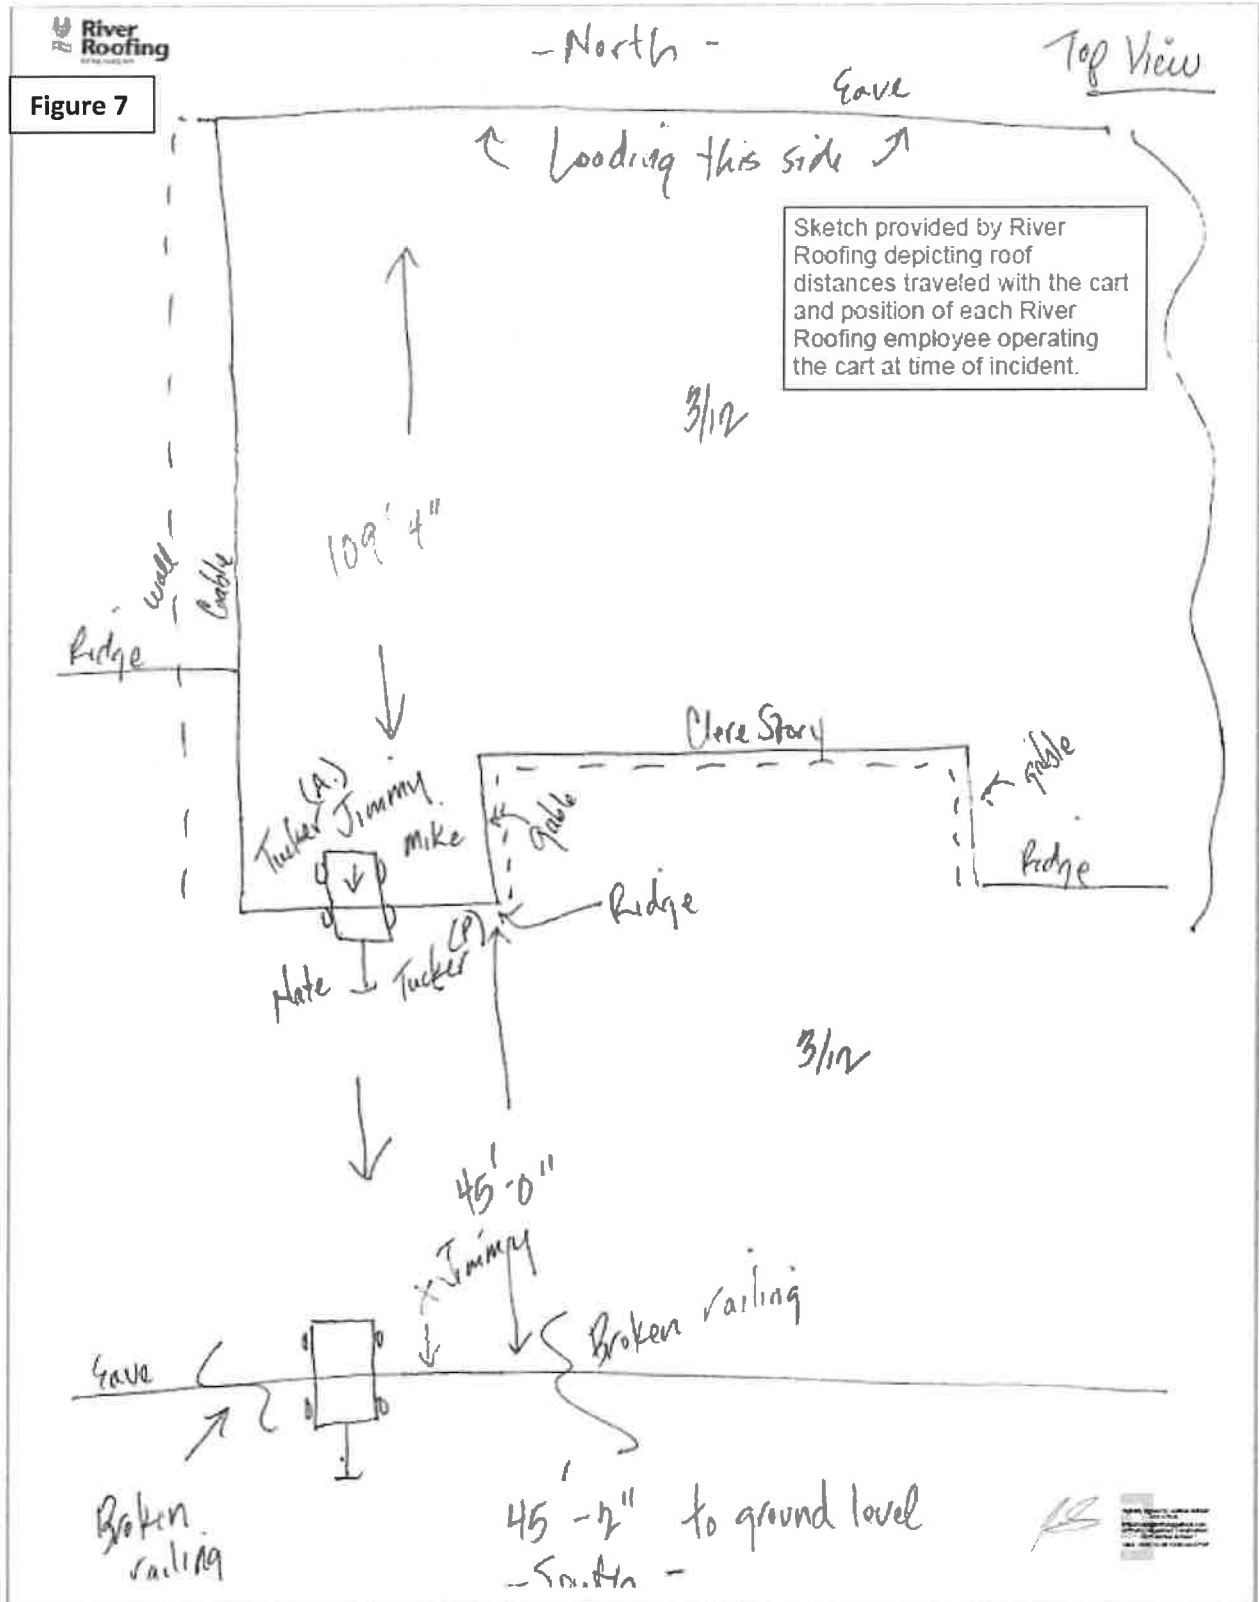
This hand drawn sketch was provided in the combined Kirby Nagelhout and River Roofing Incident report
