Aviation Investigation Preliminary Report

Location:	Madras, OR	Accident Number:	WPR24FA105
Date & Time:	March 10, 2024, 15:03 Local	Registration:	N3264W
Aircraft:	Piper PA-32-260	Injuries:	2 Fatal
Flight Conducted Under:	Part 91: General aviation - Personal

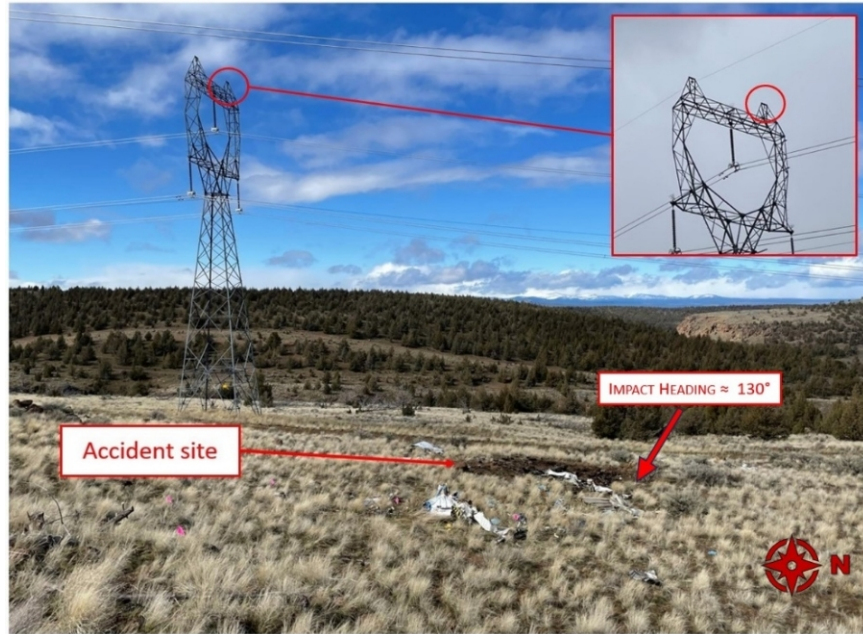
Figure 1: Accident Site Diagram

Examination of the accident site revealed that the airplane struck a static wire that spanned between two 100-ft tall high tension powerline towers, and subsequently impacted terrain between the towers. The debris path measured approximately 300 ft from the initial point of impact with the ground and was oriented on an approximate heading of about 130° magnetic.

All the major structural components of the airplane were located within the wreckage debris path. A portion of the static wire was found near the right wing.
