Oregon OSHA - ENFORCEMENT

Inspection Number: 317727743(15)
Inspection Date(s): 08/04/2020-12/08/2020
Issuance Date: 12/31/2020
Optional Rpt Num: B1514-047-20
Employer ID No: 8544595-000

Accident Synopsis

Employer Name: River Roofing Bend LLC

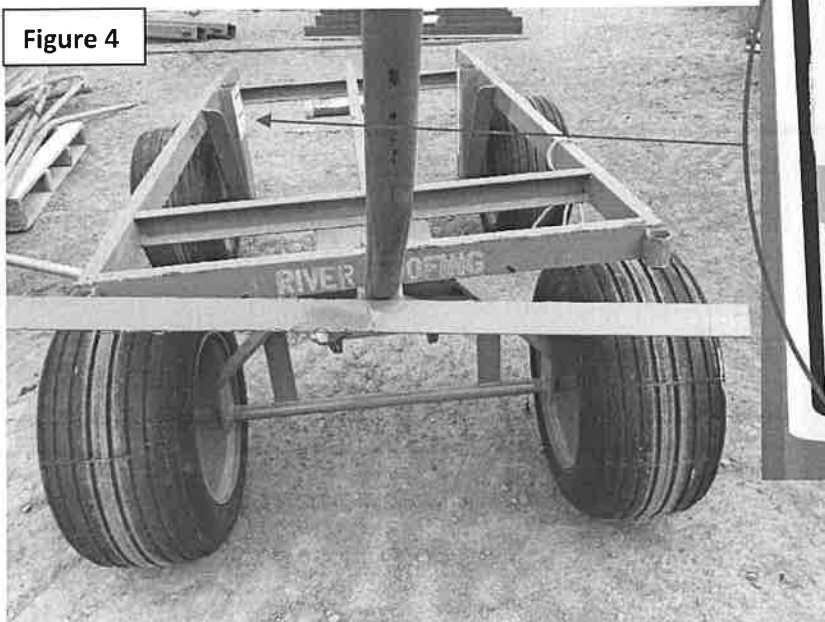
Figure 4 (OTIS Image 5895) depicts the Garlock Little Giant trailer with the drop handle disengaged by holding on to the trailer's handle.
